Subject: Plated steel fittings

Product: PEFS F3

Parts: Hydraulic adaptors and hose couplings used in the discharge system

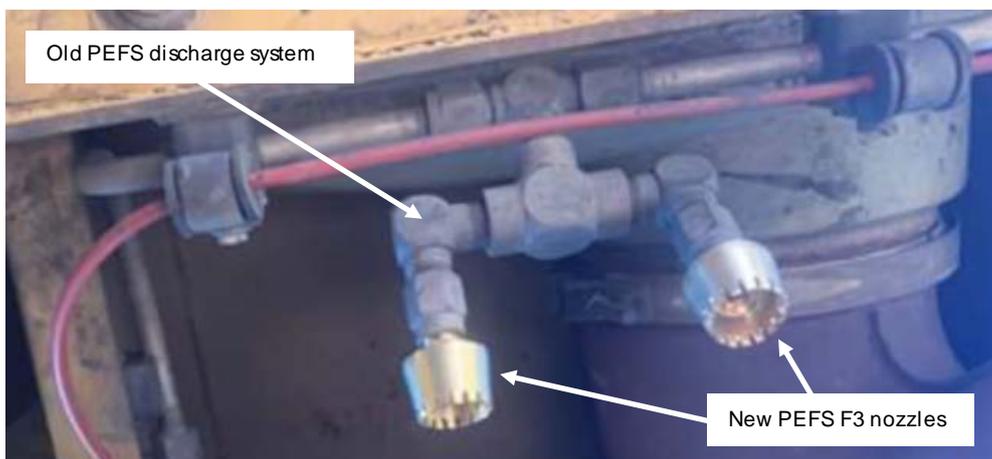
Most components of the existing PEFS discharge system, including tubing, hose, hydraulic adaptors and hose couplings, were able to be retained during the conversion process (see example in Figure 1).

Figure 1 – New PEFS F3 nozzles in old discharge system

However, plated steel fittings can deteriorate and corrode over time. To minimise blockages or impairments to the discharge nozzles from rust particles and other contaminants, it is important that the discharge system is cleaned during maintenance.

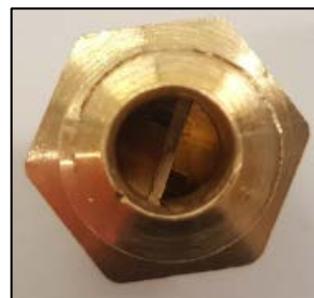
The new PEFS F3 nozzle has a smaller inside diameter (ID) than the older PEFS nozzles (refer Figures 2 and 3).

Figure 3 – PEFS F3 BM11 nozzle (rear view)

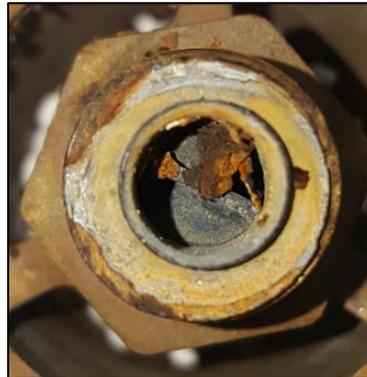
In practice, this means that the smaller ID may trap larger rust particles (refer Figure 4) or contaminants from passing through the nozzle during the system discharge.

*Figure 4 – PEFS F3 nozzle (rear view)
with rust particle*

PEFS F3 nozzles are cleaned at 6 monthly intervals and a clear passage test is carried out on the distribution system annually. These intervals are minimal requirements only. Maintenance frequencies can be increased to suit the age of equipment and/or the local conditions.

- Systems that fail to discharge correctly during the annual discharge test due to nozzle impairments (unexpected changes to nozzle spray patterns) must be cleaned and flushed according to the requirements of “Distribution System – Clear Passage Test”, Page 21 of the PEFS F3 Maintenance Manual.
- Where multiple nozzles are found to be impaired during the annual discharge test, Service technicians must recommend either increasing the frequency of the relevant routine maintenance task (cleaning and/or discharge testing), or the replacement of all plated steel fittings in the discharge system.
